Preliminary Geotechnical Investigation and Peer Review

<b>TYPE OF SERVICES</b>	Preliminary Geotechnical Investigation
<b>PROJECT NAME</b>	Hill Valley Oaks Apartments
<b>LOCATION</b>	Arnold Drive Martinez, California
<b>CLIENT</b>	Hill Valley Oaks, LLC
<b>PROJECT NUMBER</b>	351-1-1
<b>DATE</b>	November 17, 2009 Revised December 11, 2009

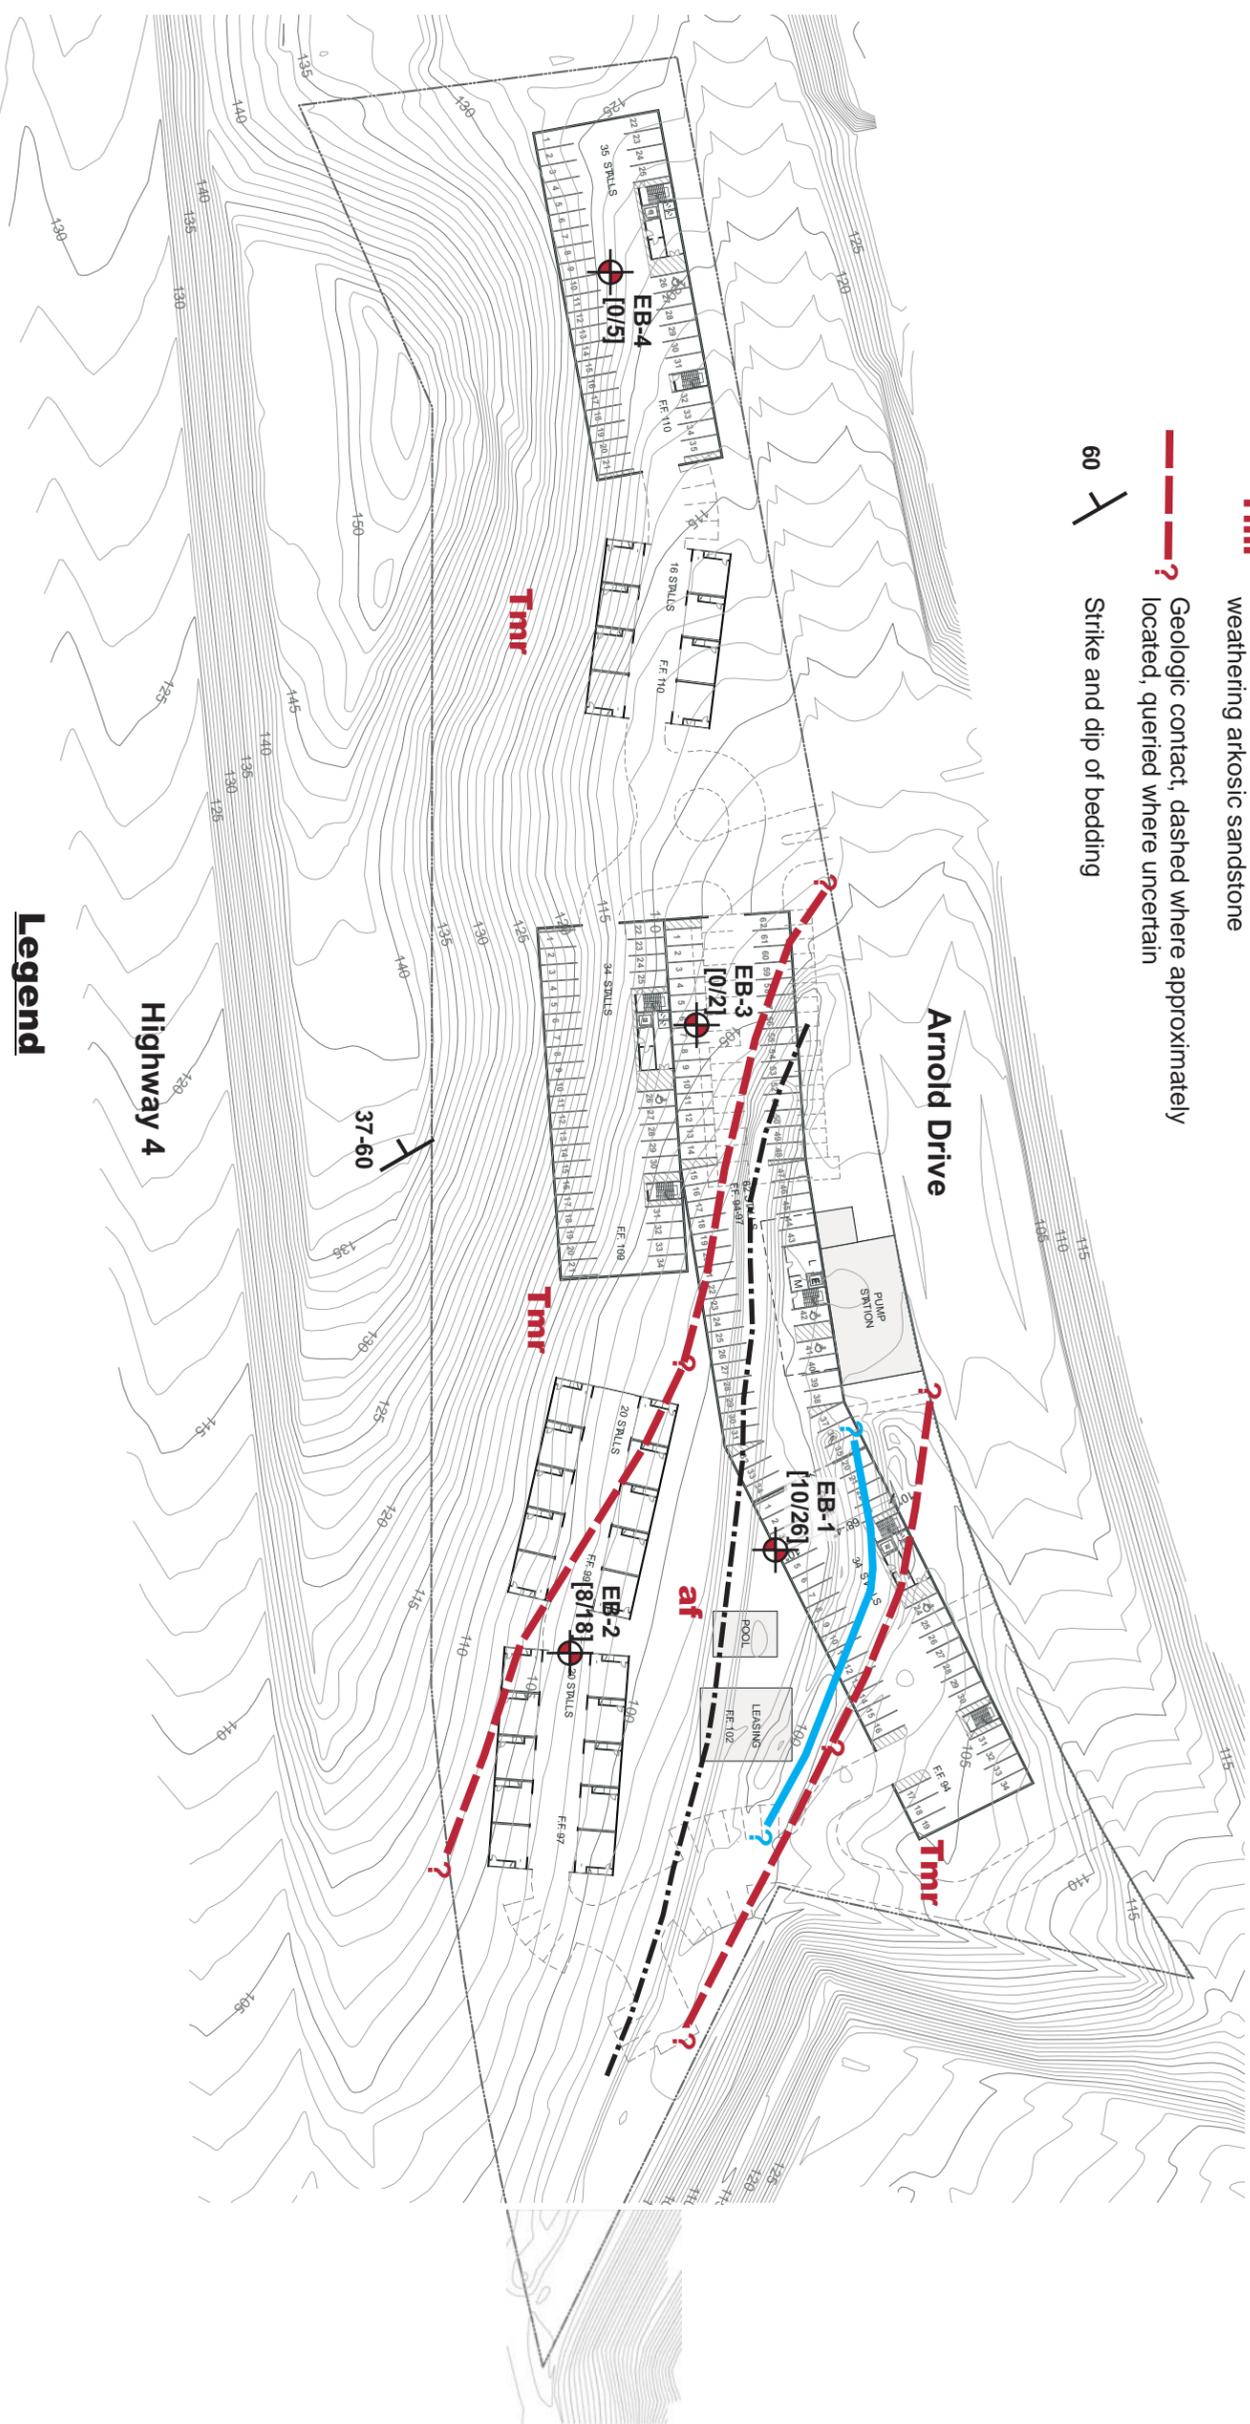
**---** Geologic contact, dashed where approximately located, queried where uncertain

**60** Strike and dip of bedding

### Legend

Approximate location of exploratory boring

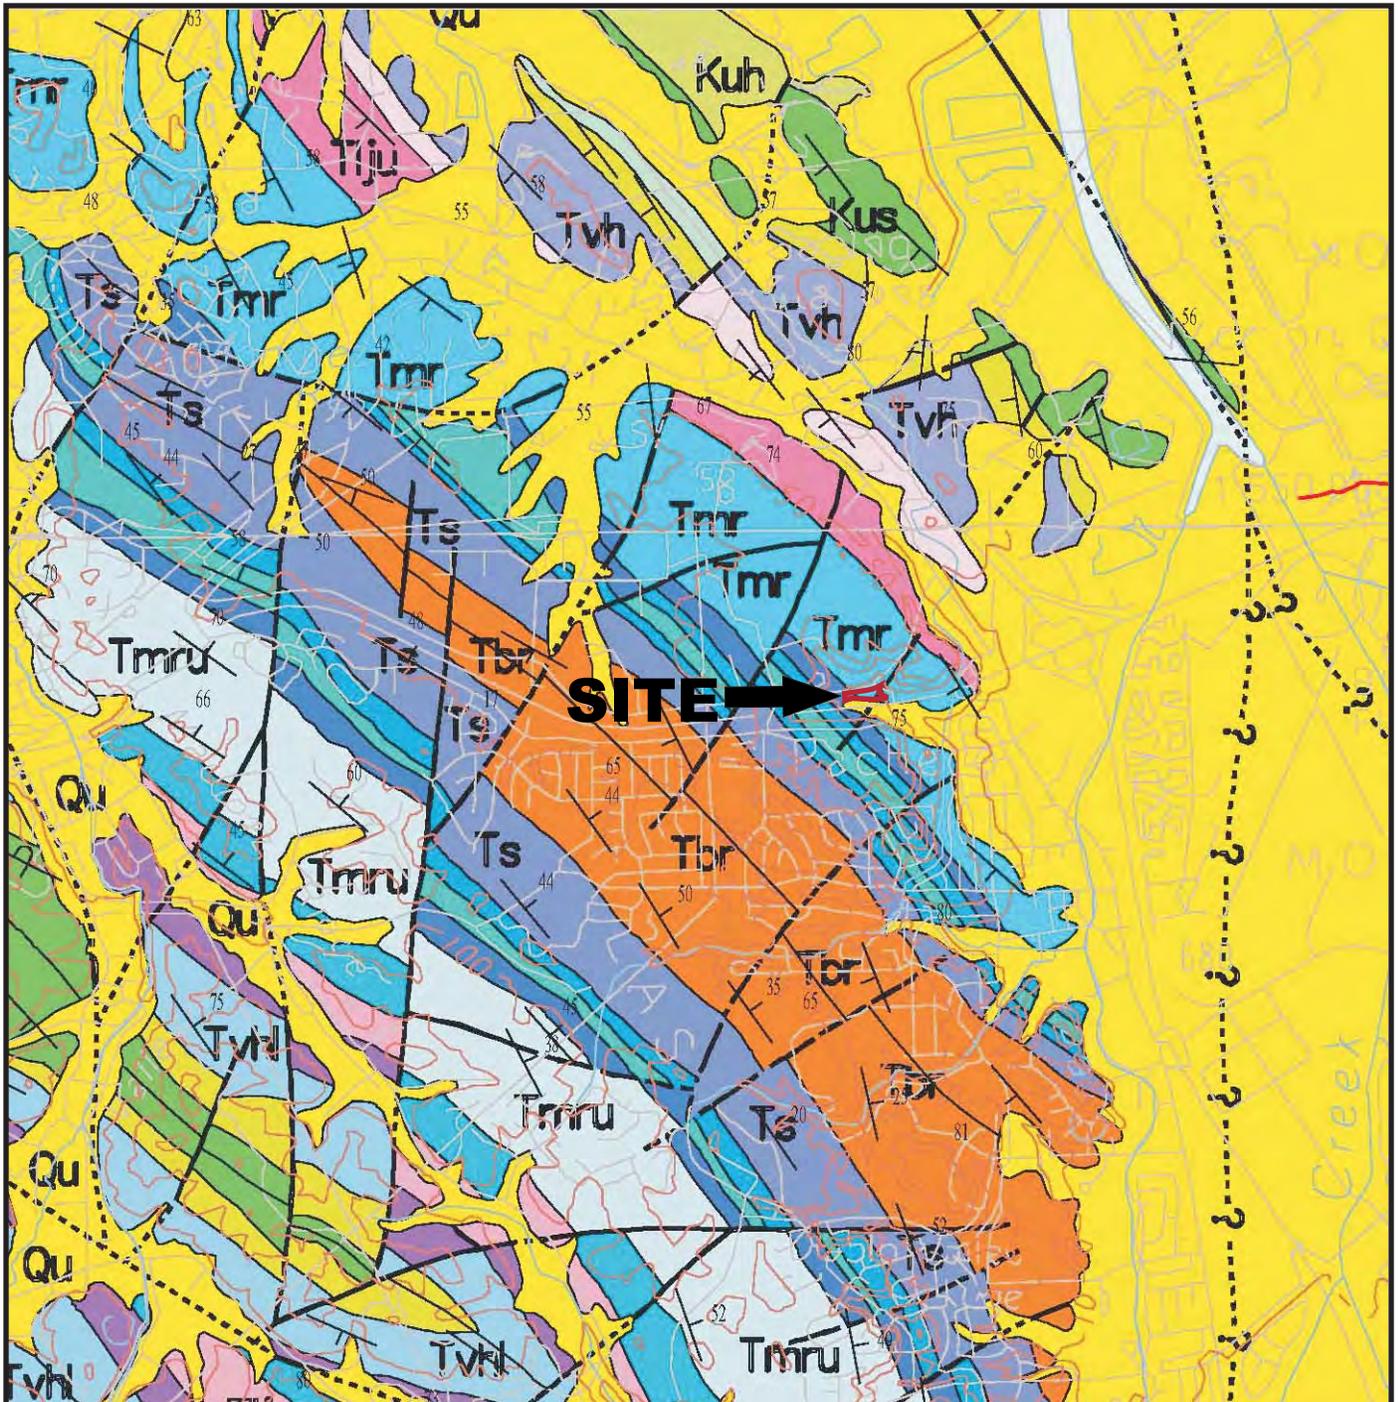
Project Number	351-1-1
Figure Number	Figure 3
Date	November 2009
Drawn By	FLL

**Local Geologic Units**

- Tmr Muir Sandstone - massive, yellow, weathering arkosic sandstone
- Tbr Briones Formation, sandstone, siltstone, conglomerate and shell breccia

**Regional Geologic Map**  
**Hill Valley Oaks Apartments**  
**Martinez, CA**

Graymer et al. (1994) identify bedrock of the site area as Muir sandstone of Weaver (1953), as shown on the Regional Geologic Map, Figure 3. This is described as non-marine sandstone, massive, yellow, weathering arkosic sandstone. This unit is thought to be Miocene or Pliocene in age. Their map shows bedding dipping roughly 60 to 75 degrees to the southwest in the hills north, south and east of the site. A splayed trace of a Concord-Green Valley fault covered by Quaternary alluvium is shown east of the site, crossing the Concord area. Numerous smaller unnamed, inactive faults cross the site vicinity, including one mapped near the east end of the site.

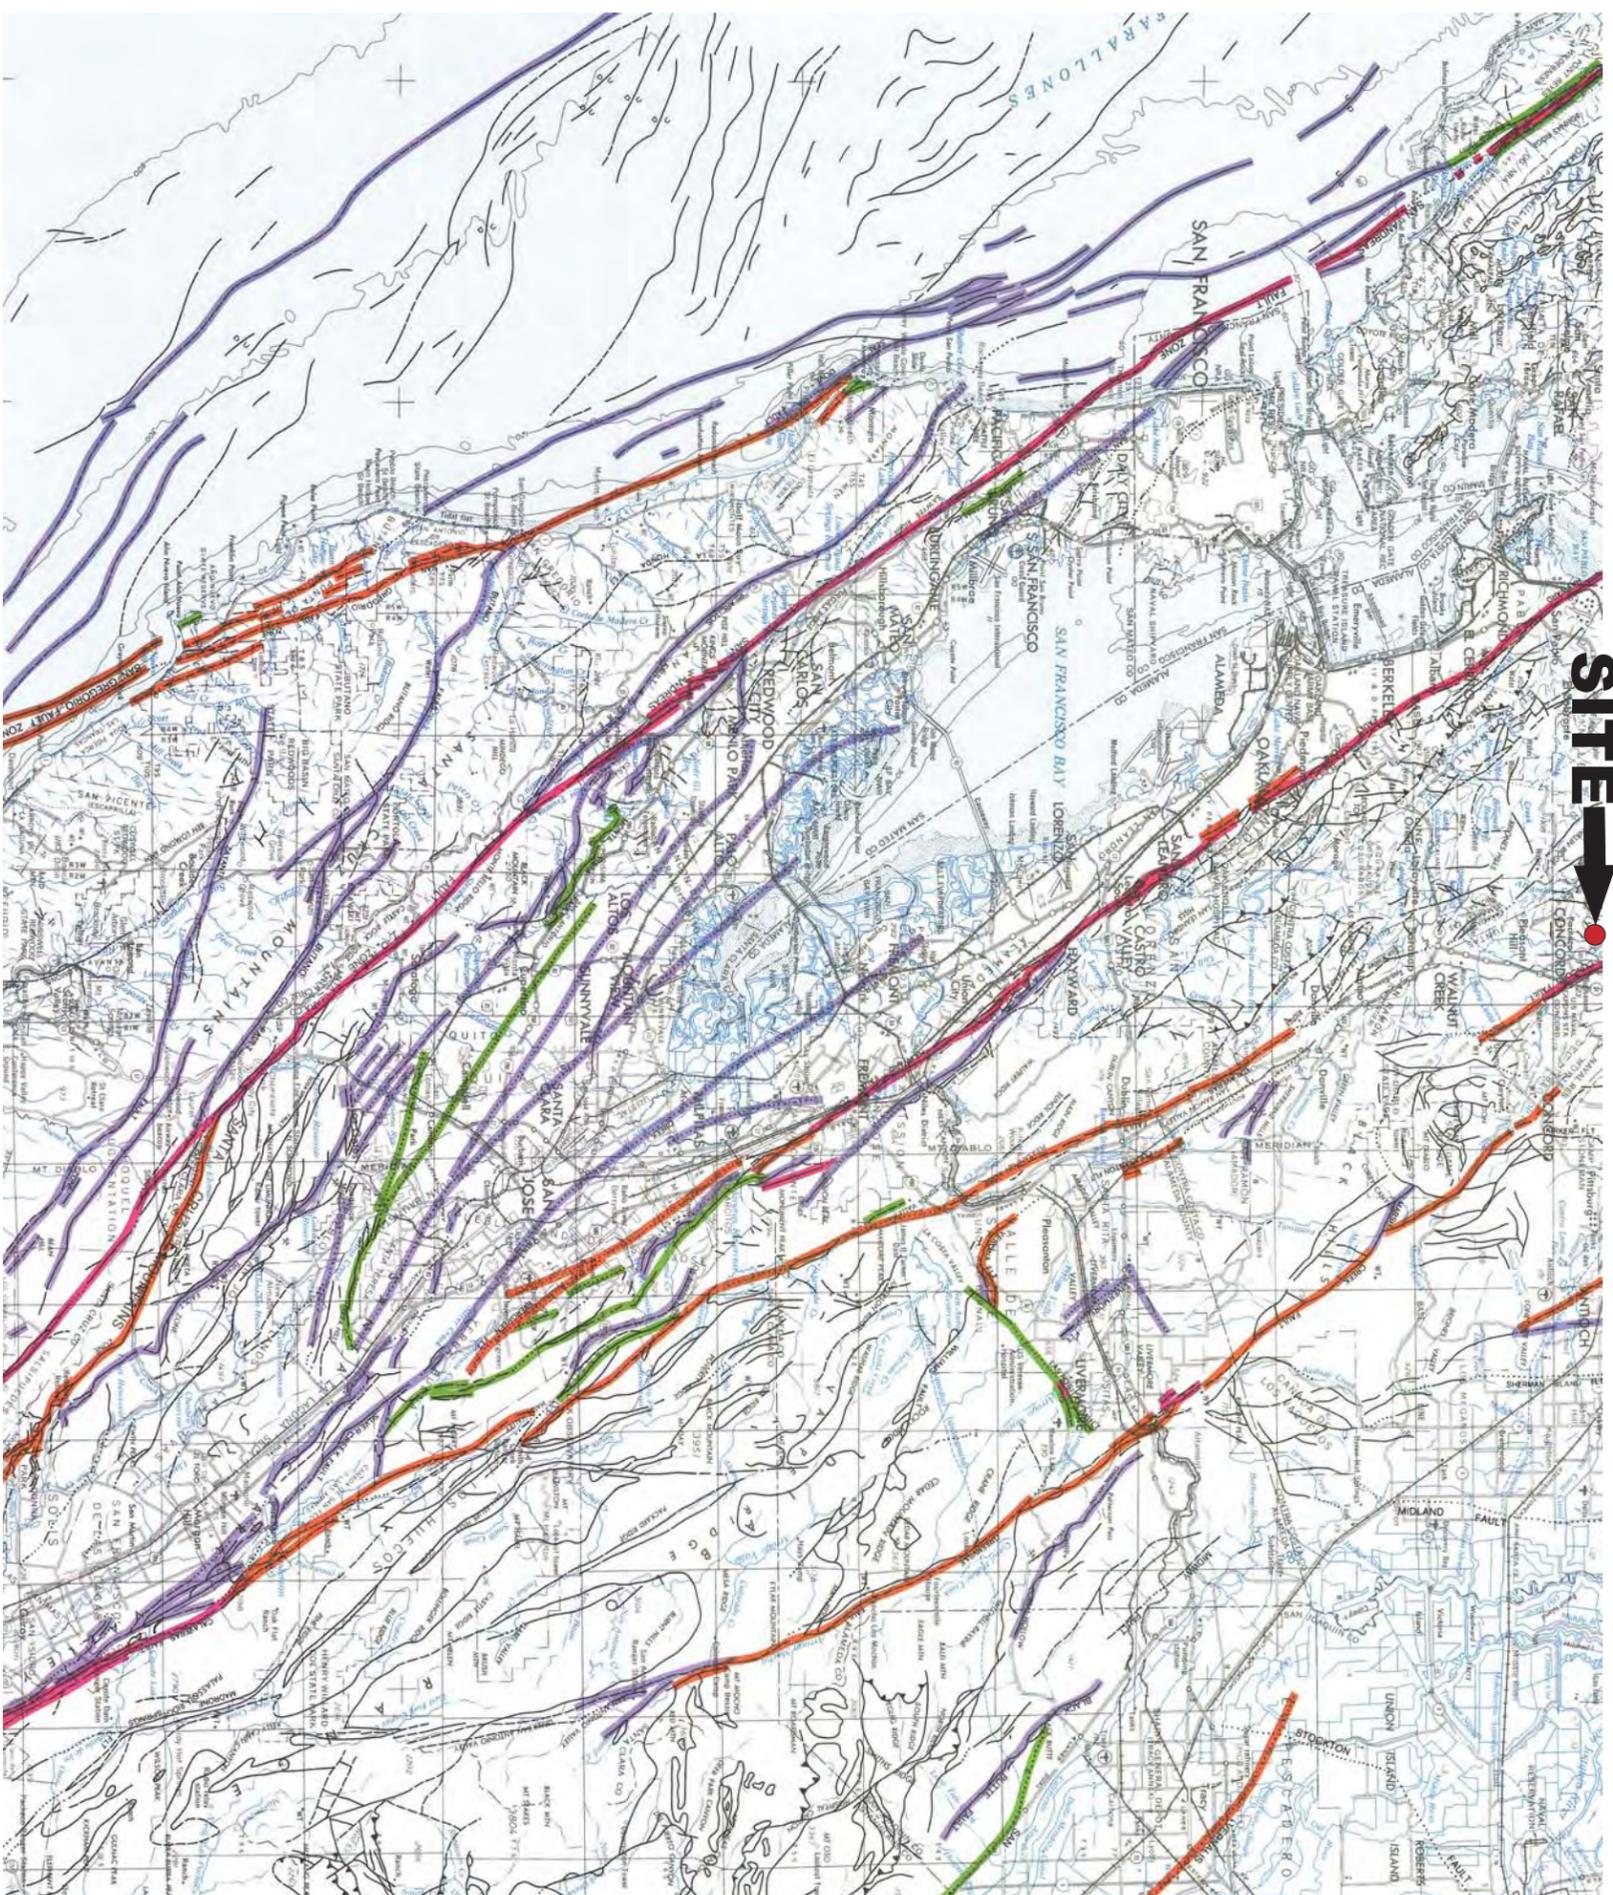
Geologic Time Scale	Quaternary		Years Before Present (Approx.)	Fault Symbol	Recency of Movement on Land/Offshore	DESCRIPTION
	Pre-Quaternary	Quaternary				
Miocene	Pliocene	Early Quaternary	2,000,000 - 700,000	Blue line	Blue line	Faults showing evidence of no displacement during Quaternary time.
		Pleistocene	700,000 - 10,000	Green line	Green line	Quaternary (undifferentiated) faults - most faults in the last 2,000,000 years; possible exceptions are faults which displace rocks of undifferentiated Pleistocene age.
		Holocene/Recent	10,000 - 200	Orange line	Orange line	Faults showing evidence of displacement during late Quaternary time.
		Historic	200 - Present	Red line	Red line	Displacement during historic time (e.g. San Andreas fault 1906). Includes areas of known fault creep.

As discussed above several significant faults are located within 30 kilometers of the site. The site is not located within a State-designated Alquist Priolo Earthquake Fault Zone. As shown in Figure 4, no known surface expression of active fault traces is thought to cross the site; therefore, fault rupture hazard is not a significant geologic hazard at the site.
